NATIONAL TRANSPORTATION SAFETY BOARD
Vehicle Recorder Division
Washington, DC 20594

Sound Spectrum Study

Specialist's Factual Report
By Sean Payne

Location:	Williams, Arizona
Date:	April 15, 2021
Aircraft:	Cessna 140
Registration:	N2506N
Operator:	Private
NTSB Number:	WPR21LA166

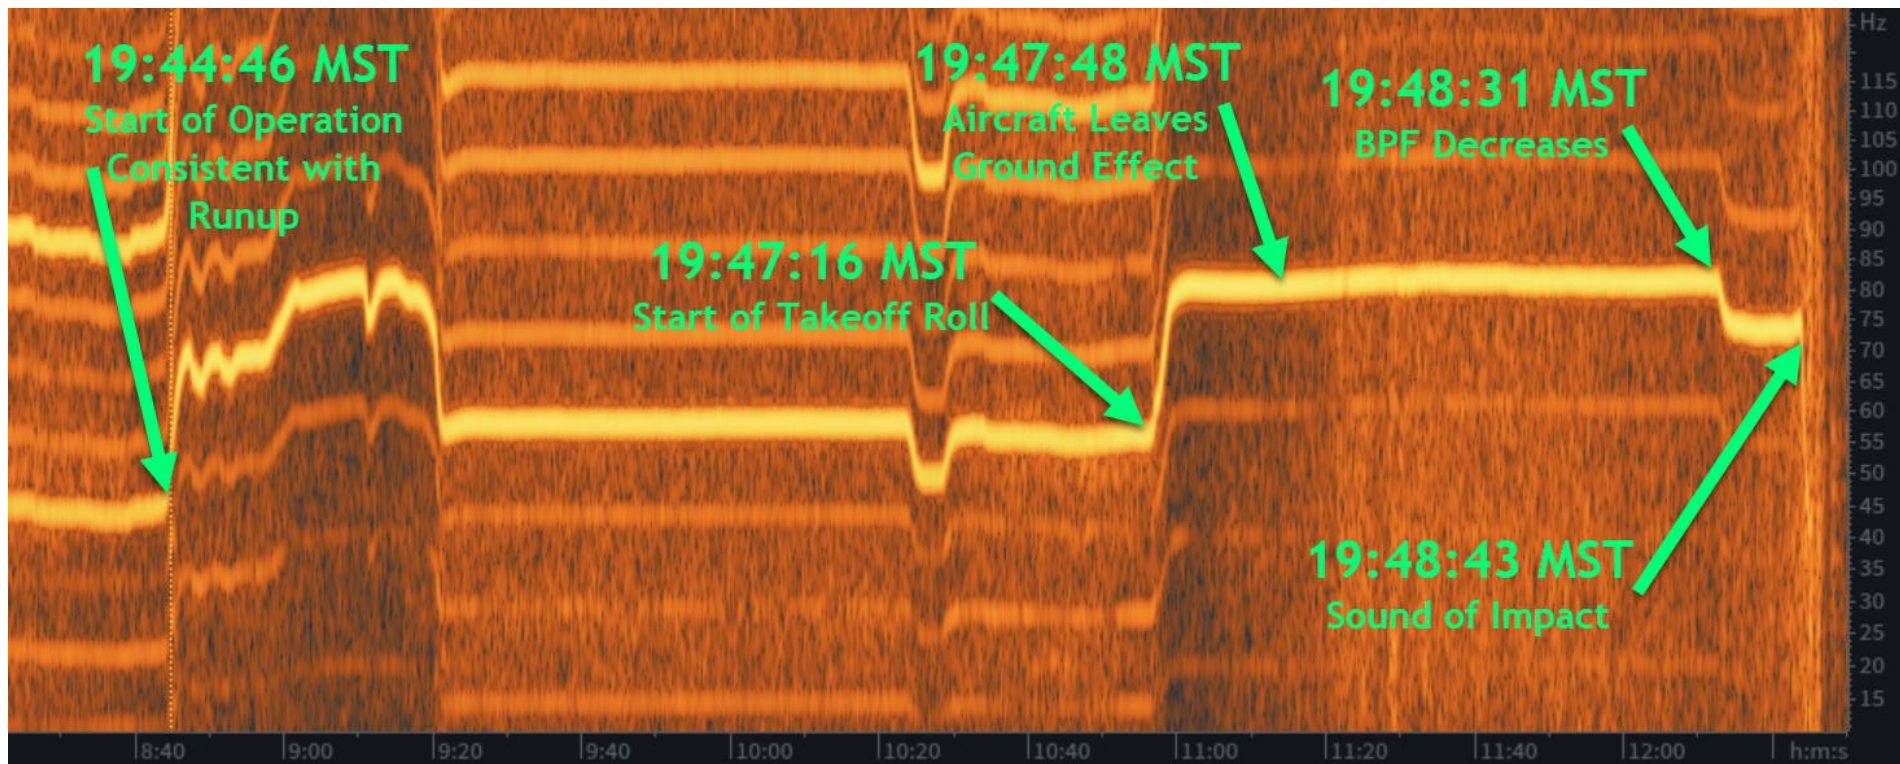
Figure 1 shows the lower frequency sounds generated by the engine and propeller during the video. The time of this figure is given in the x-axis and is displayed as elapsed time of the recording. The y-axis is a measure of the frequency. Correlation to local time was made by comparing the sound spectrum data to the information from the Onboard Image Recorder – Specialist's Factual Report.

Selected local time offsets have been annotated on this figure for clarity. An event consistent with an engine runup began at 19:44:46 MST, application of takeoff power began at 19:47:16 MST, the aircraft began flying outside of ground effect at 19:47:48 MST, the sound of the engine noise becoming lessened occurred at 19:48:31 MST, and the impact with terrain occurred at 19:48:43 MST.

Figure 1. A sound spectrum graph of the aircraft during the entire accident flight, with relevant times from the Onboard Image Report annotated.

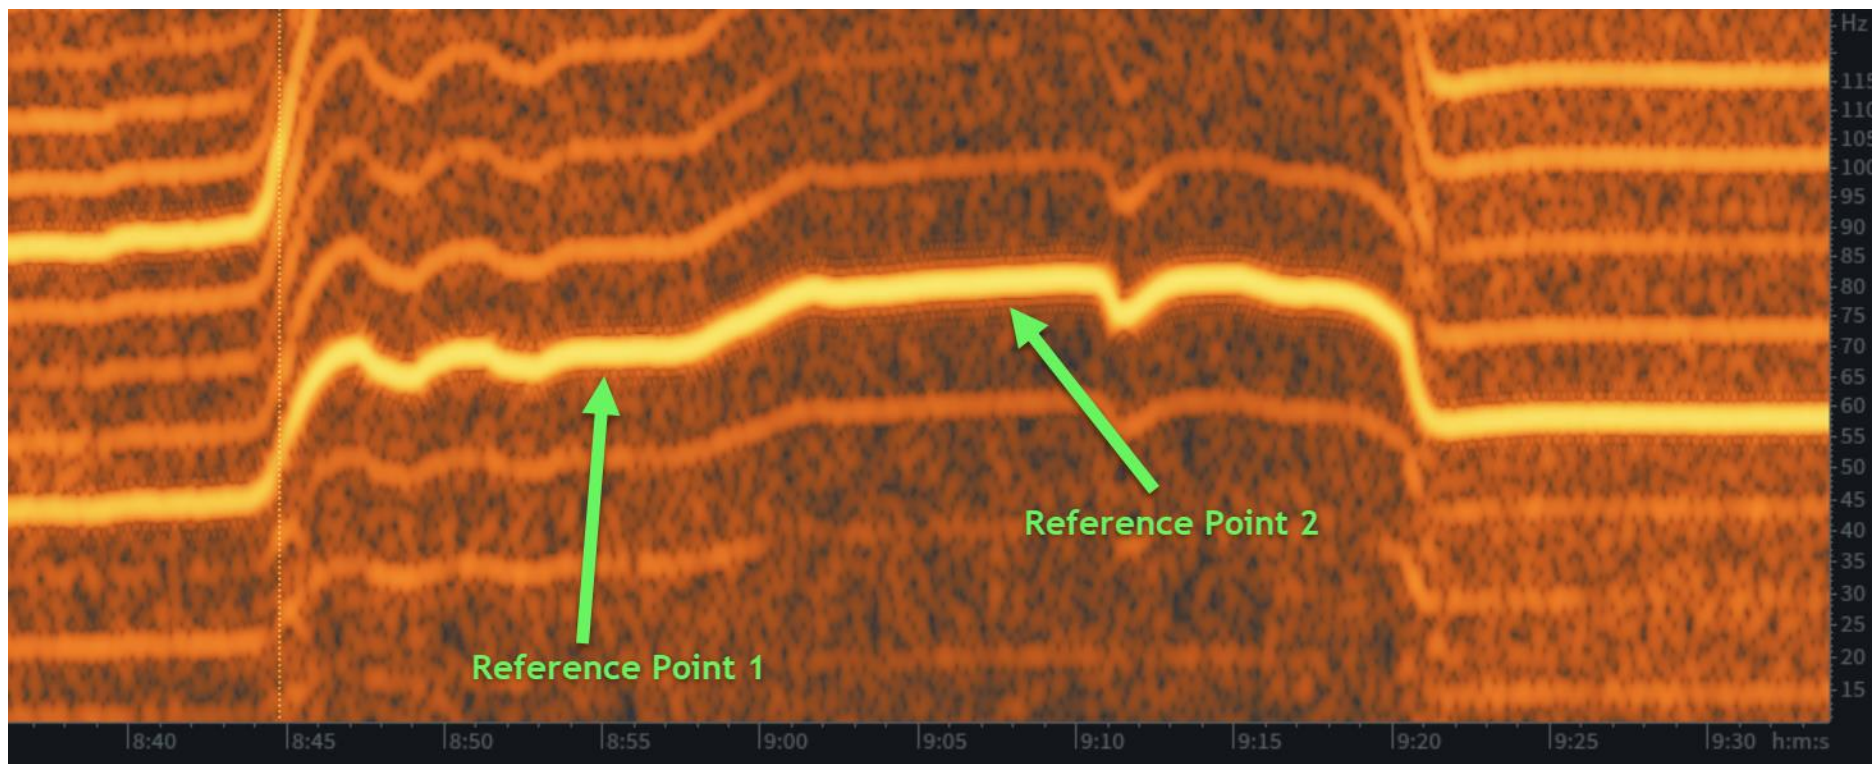
Figure 2 shows the area of audio consistent with a runup operation in detail. Two time points are annotated, reference point 1 and reference point 2. The measured blade pass frequency at reference point 1 is 69.03 Hz and the measured BPF at reference point 2 is 80.30 Hz. The calculated BPF at each point was 2071 RPM and 2409 RPM, respectively.

Figure 2. An expanded and annotated screenshot of the sound spectrum image consistent with an area of aircraft engine run up.

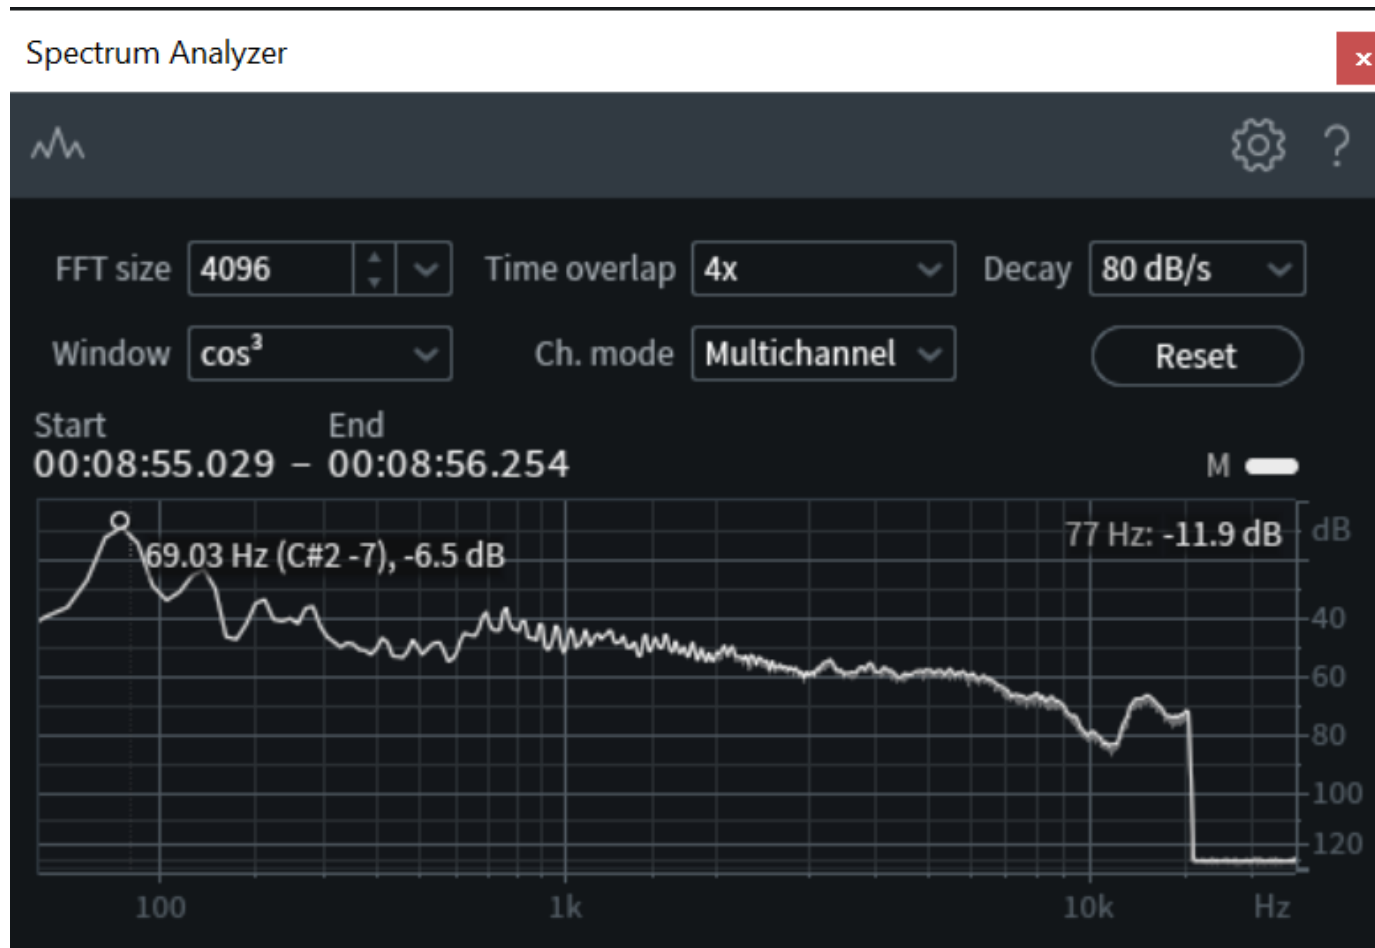
Figure 3 is a Fast Fourier Transform (FFT) at reference point 1 during the area of audio consistent with an engine runup. The measured BPF at reference point 1 is

69.03 Hz. The settings used to create the FFT are shown in the captured window. The measured BPF at this time was calculated to be 2071 RPM.

Figure 3. The blade pass frequency measured at reference point 1 as 69.03 Hz or 2071 RPM.

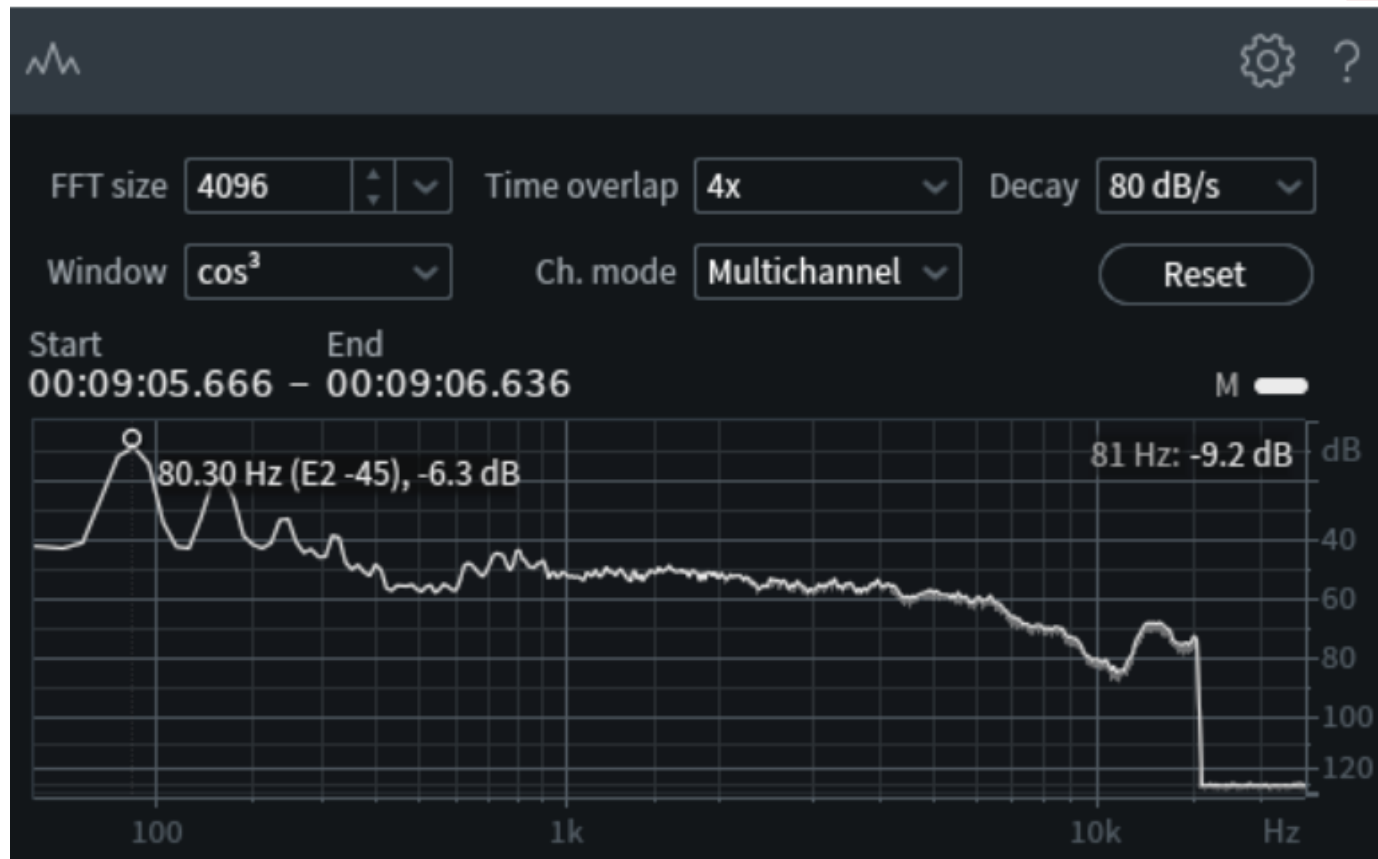
Figure 4 is a Fast Fourier Transform (FFT) at reference point 2 during the area of audio consistent with an engine runup. The measured BPF at reference point 2 is 80.30 Hz. The settings used to create the FFT are shown in the captured window. The measured BPF at this time was calculated to be 2409 RPM.

Figure 4. The blade pass frequency measured at reference point 2 as 80.30 Hz or 2409 RPM.

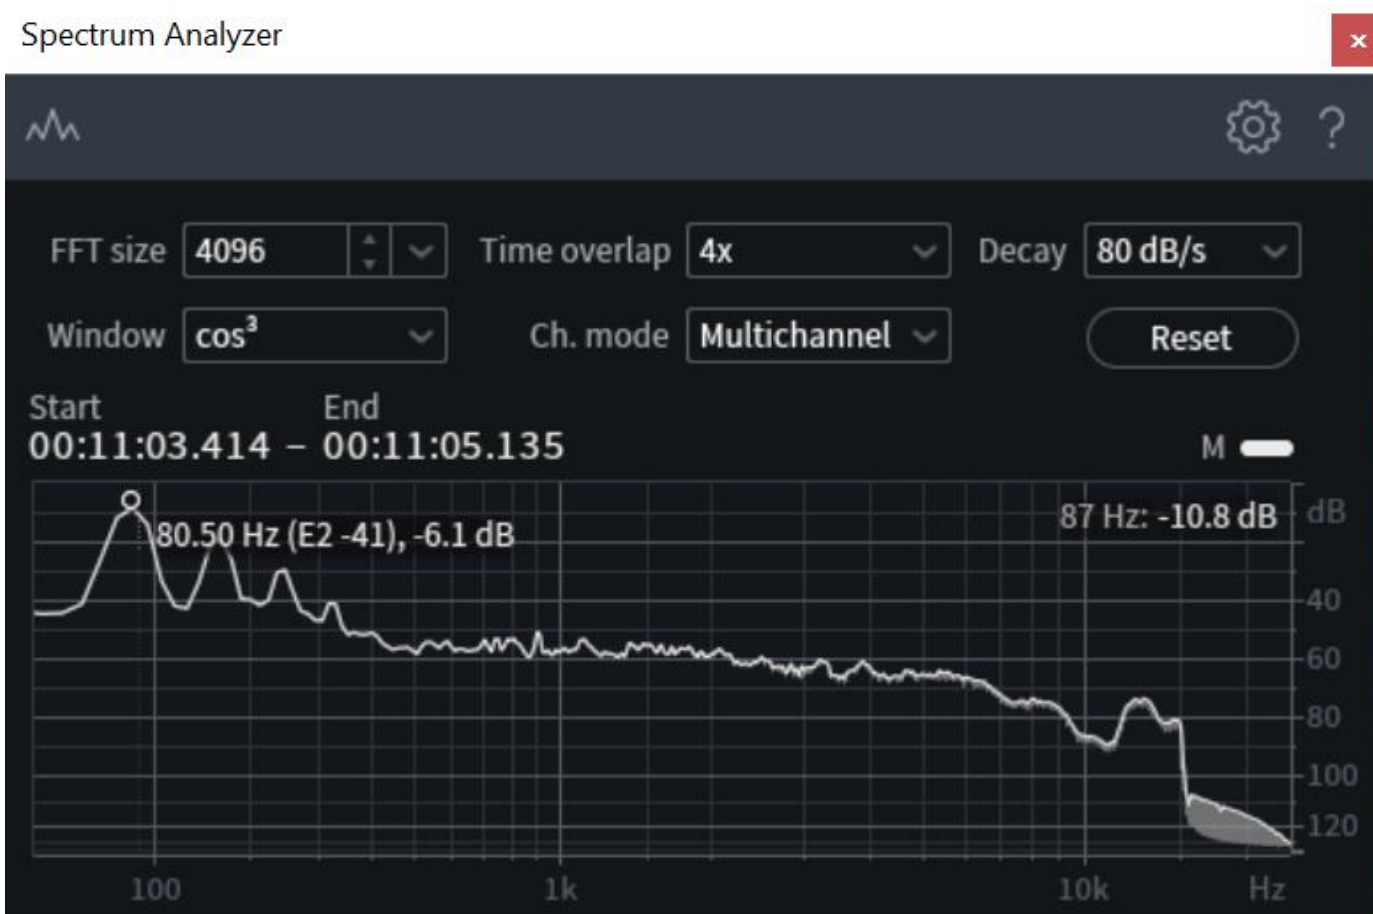
Figure 5 is a Fast Fourier Transform (FFT) at a time just after 19:47:16 when a sound was detected that was consistent with takeoff power having been applied. The measured BPF at this reference point is 80.50 Hz. The settings used to create the FFT are shown in the captured window. The measured BPF at this time was calculated to be 2415 RPM.

Figure 5. The blade pass frequency measured just after 19:47:16 MST (just after takeoff roll started) as 80.50 Hz or 2415 RPM.

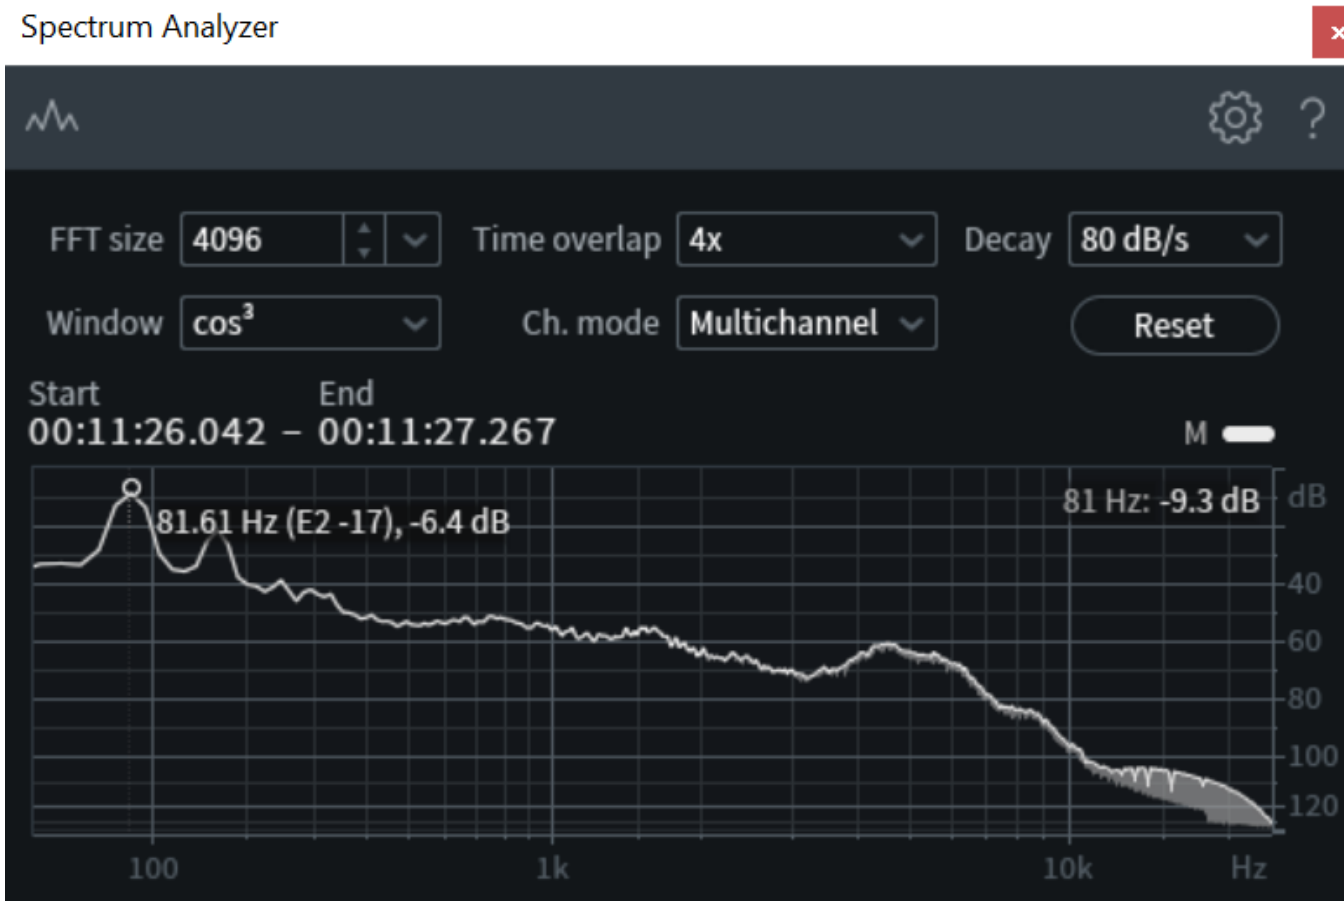
Figure 6 is a Fast Fourier Transform (FFT) at time just after 19:47:48 when the aircraft had appeared to leave ground effect. The measured BPF at this reference point is 81.16 Hz. The settings used to create the FFT are shown in the captured window. The measured BPF at this time was calculated to be 2448 RPM.

Figure 6. The blade pass frequency measured just after 19:47:48 MST (just after the aircraft left ground effect) as 81.61 Hz or 2448 RPM.

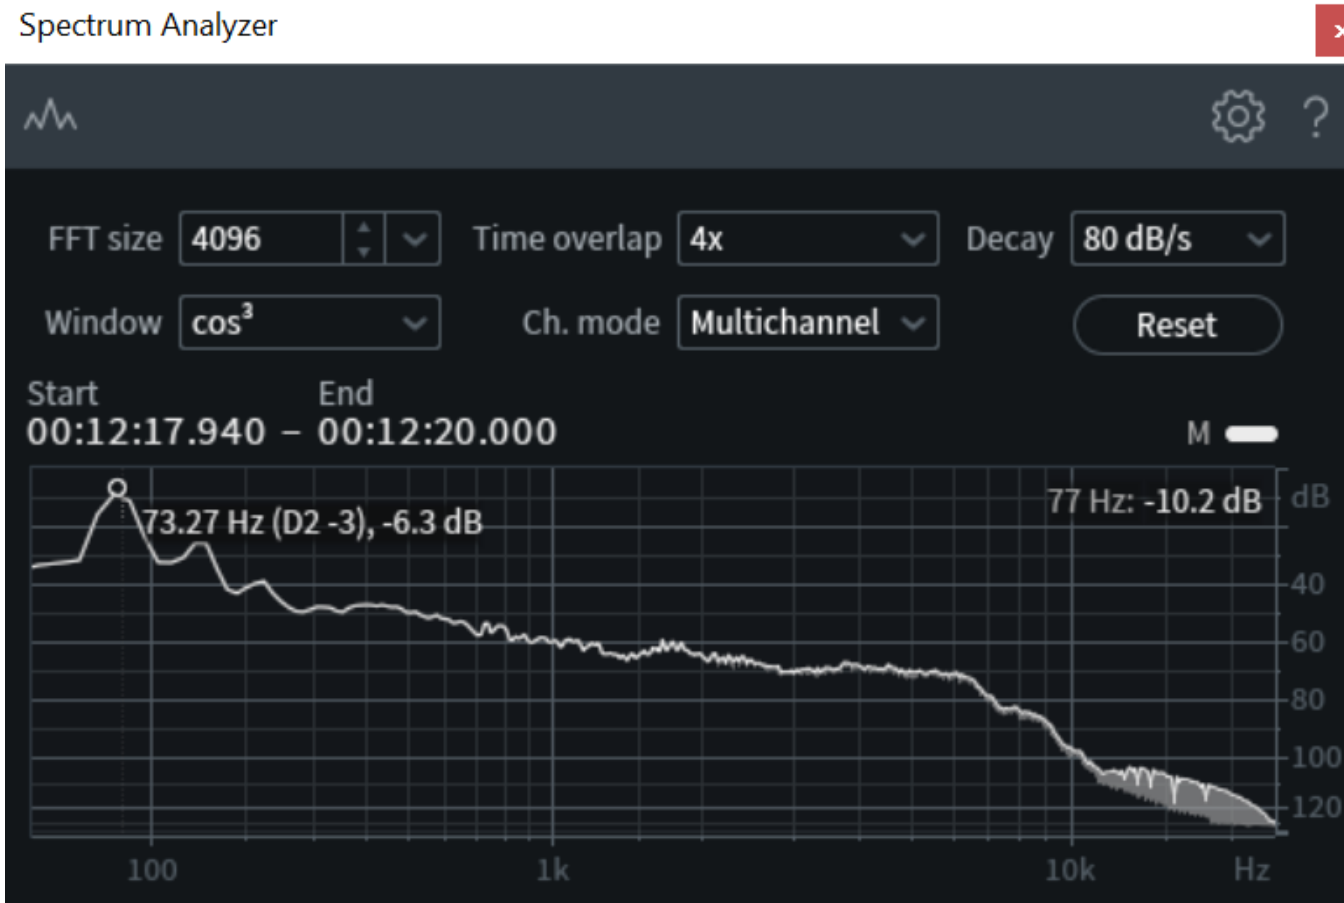
Figure 7 is a Fast Fourier Transform (FFT) at a time just after 19:48:31 when a sound was detected that was consistent engine power having been reduced. The measured BPF at this reference point is 73.27 Hz. The settings used to create the FFT are shown in the captured window. The measured BPF at this time was calculated to be 2198 RPM.

Shortly thereafter, at 19:48:43 MST, the aircraft impacted terrain. The sound spectrum information just prior to impact was similar to the data reported in figure 7.

Figure 7. The blade pass frequency measured just after 19:48:31 MST (just after a sound of lessened engine power was audible) as 73.27 Hz or 2198 RPM.
